DOT/FAA/CT-92/04

Commuter/Air Taxi Ditchings and Water-Related Impacts that Occurred from 1979 to 1989

Final Report

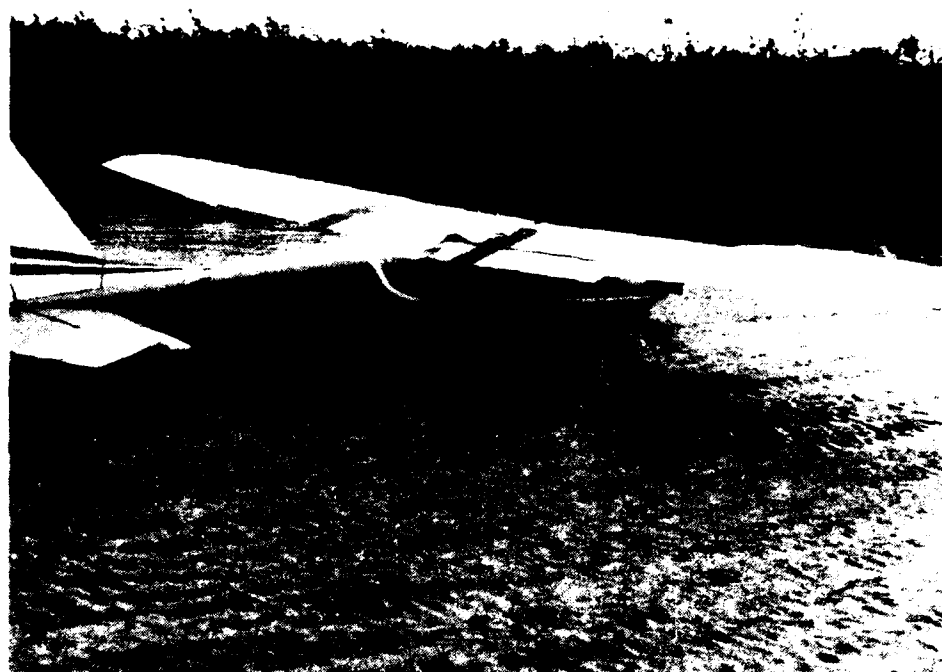
- a. Right wing substantially damaged (figures 4.1, 4.2).
- b. Right wing flap slightly displaced (figure 4.3).
- c. Propeller blade bent.

FIGURE 4.3. CASE STUDY 3, FULL VIEW OF RIGHT FUSELAGE

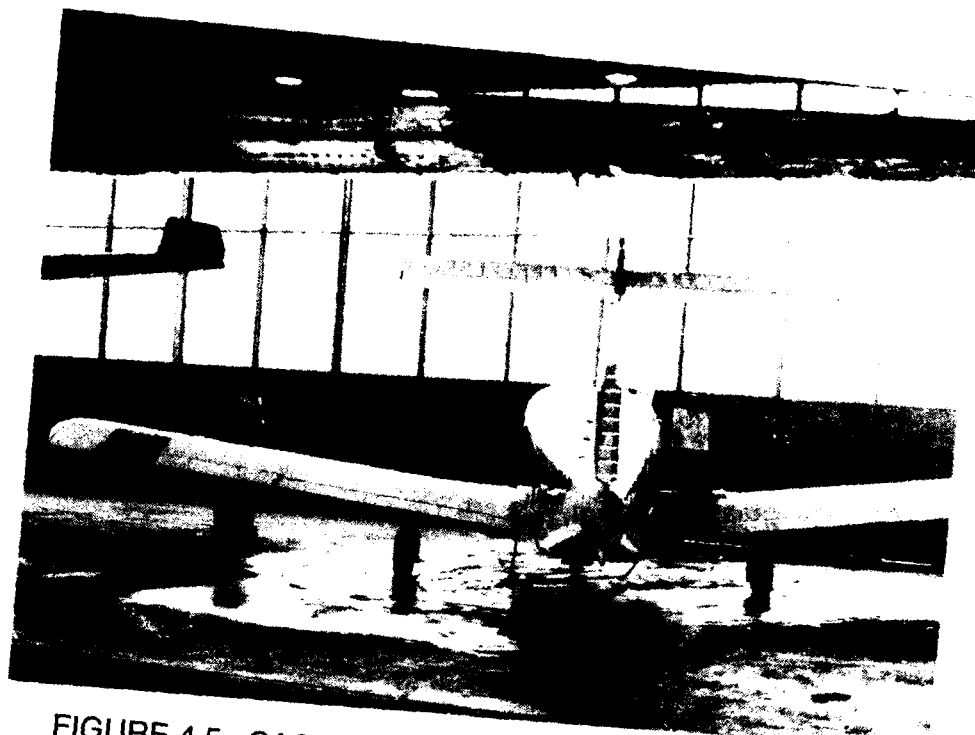
FIGURE 4.5. CASE STUDY 4, REAR VIEW OF AIRCRAFT

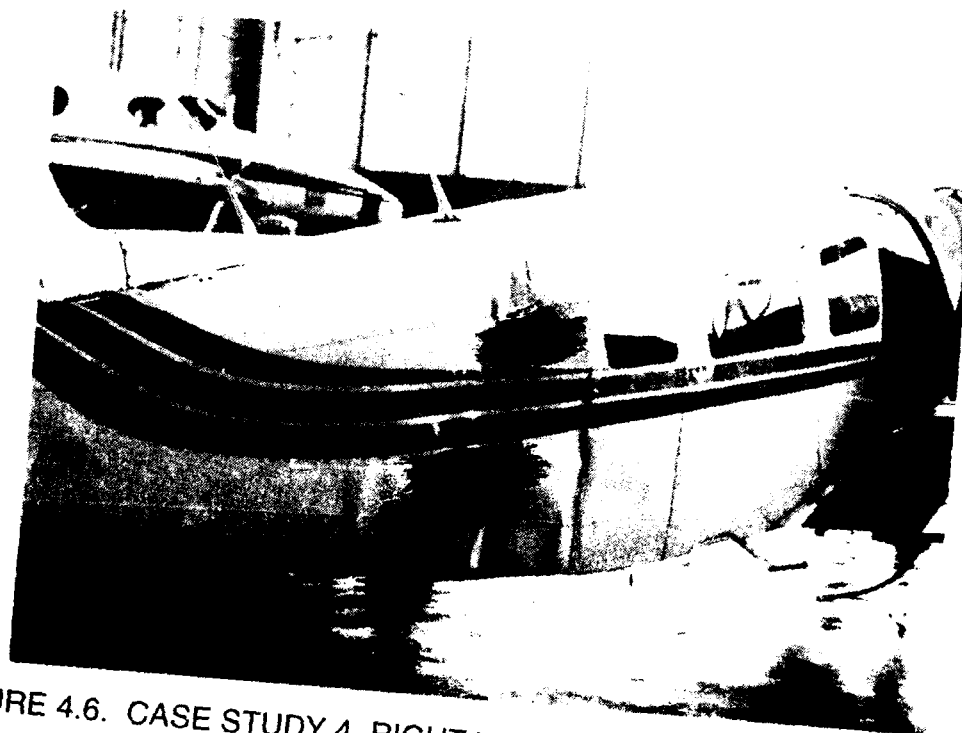
FIGURE 4.6. CASE STUDY 4, RIGHT VIEW OF REAR FUSELAGE DAMAGE

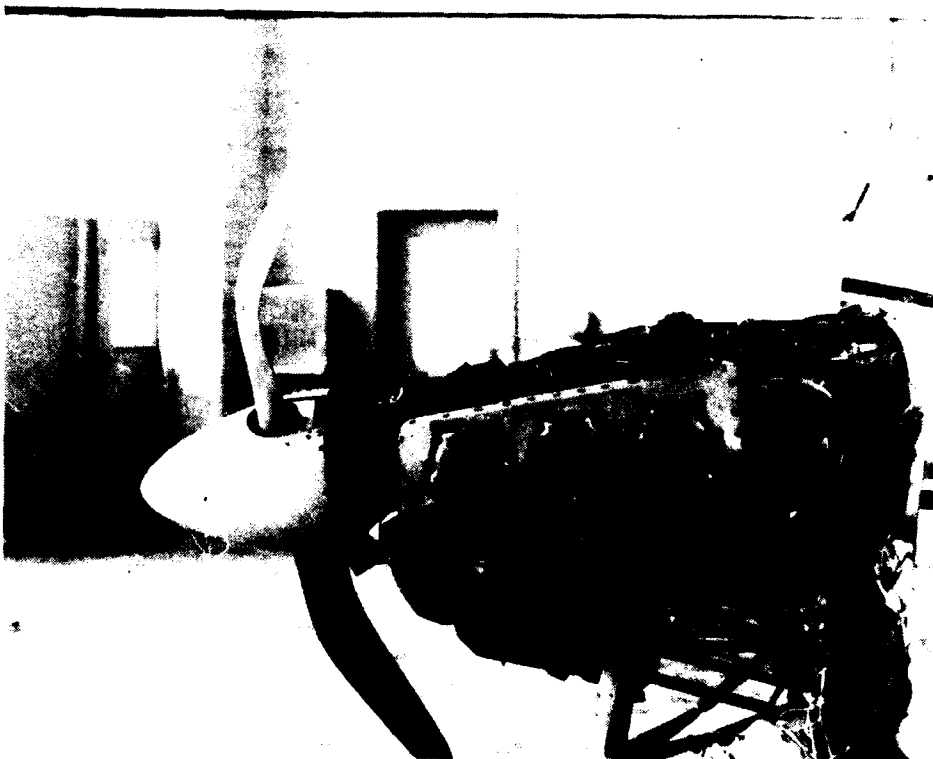
FIGURE 4.8. CASE STUDY 4, LEFT VIEW OF NOSE DAMAGE

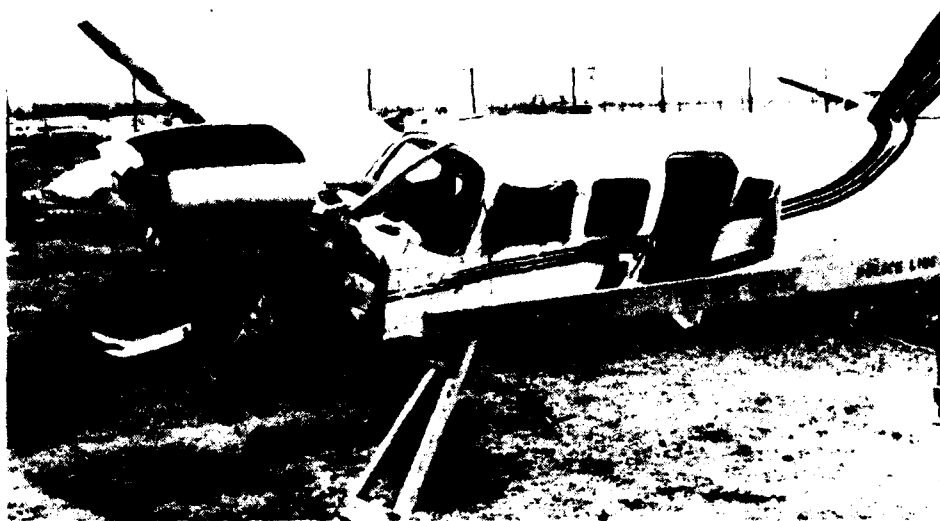
- a. Left wing completely separated from fuselage and inverted (figure 4.11).
- b. Forward upper left fuselage side indentation resembling left wing tip (figure 4.11).
- c. Fuselage door under the wing (figure 4.11).
- d. Left, right, and nose gear in down position (figure 4.12).
- e. Nose wheel and lower part of nose strut missing (figure 4.11).
- f. Right wing tip missing (figure 4.12).
- g. Rudder slightly wrinkled.
- h. Nose crush damage (figure 4.11).

FIGURE 4.11. CASE STUDY 6, FULL VIEW OF LEFT FUSELAGE DAMAGE

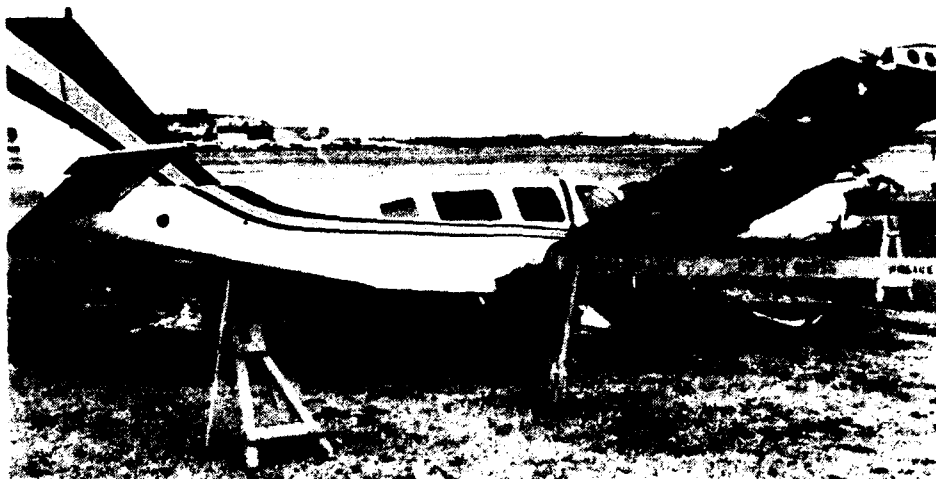
FIGURE 4.12. CASE STUDY 6, FULL VIEW OF RIGHT FUSELAGE DAMAGE
